SCOTT'S – BELL 47, INC.

INFORMATION LETTER 47-15-11

Subject: Inspection/Repair of P/N 74-140-914-31

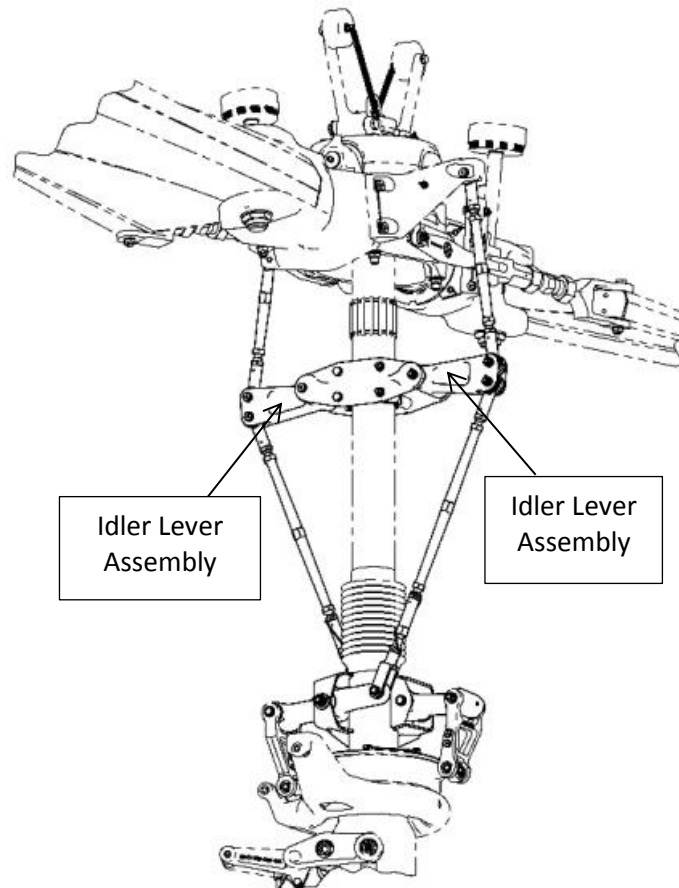
The suspect part is the "Idler Lever Assembly", P/N 74-140-914-31. This lever is a component of STC SH2772SW, also known as the "No Bar Kit". Each STC Kit contains two Idler Lever Assemblies.

It has been determined that the pivot bearings may have been incorrectly installed, preventing the bearings from receiving proper lubrication.

Fig. 1: Location of Idler Lever Assembly

- a) Remove both suspect Idler Lever Assemblies from the aircraft (if installed).
- b) Ship the two suspect Idler Lever Assemblies to SB47 at the following address:

- c) SB47 will have the parts inspected and, if necessary, repaired within 4 days of receipt with no charge to the customer.
- d) SB47 will ship the parts back to the sender with no charge to the customer.
- e) Install the Idler Lever Assemblies as per STC Installation Instructions.
- f) Make the appropriate logbook entry in the aircraft maintenance records that shows this Information Letter has been complied with.
